Subject: EXAMINATION OF PROLENE* (POLYPROPYLENE)
SUTURES FROM HUMAN CARDIOVASCULAR EXPLANTS

ERF ACCESSION NO.

84-194

PROJECT NO. 16104

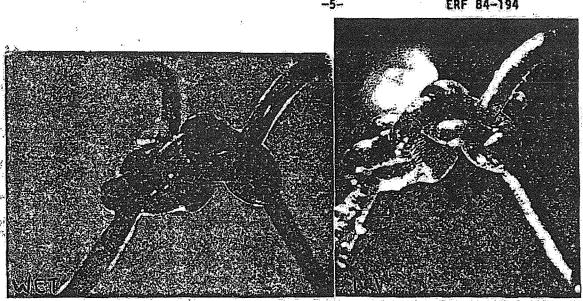
Sample 6 showed evidence of severe surface cracking by light microscopic examination. The appearance of the cracked layer was not always apparent when the specimens were examined in a wet condition but were dramatically evident in dry segments of identical areas, Figure 1 & 2. However, one sample did show evidence of a cracked layer when wet and dry, Figure 3. The cracked surface layer appeared blue when examined against a light colored background, Figure 4.

Figure 1 - Knot from sample 6 examined under wet and dry conditions. Cracking is more readily apparent in dry samples, 7 years size 5-0, magnification x40.

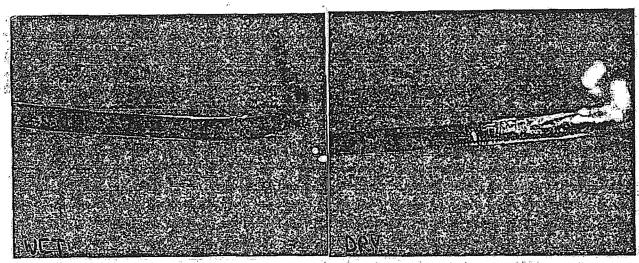
Figure 2 - Strand from sample 6 examined under wet and dry conditions. Cracking is more readily apparent in dry samples, 7 years, size 5-0, magnification X40.

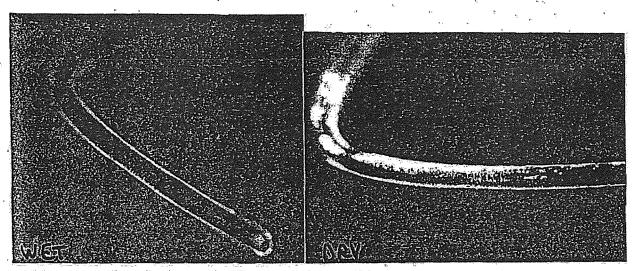
Figure 3 - Sample 6 examined under wet conditions showing some evidence of surface cracking which is more dramatic in the dry sample, 7 years, size 5-0, magnification x40.

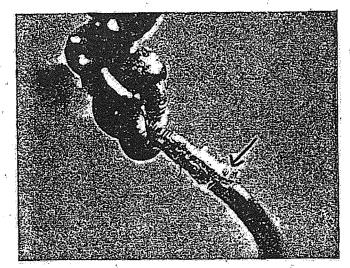
of the cracked layer over time. The cracked layer appeared blue in gross specimens and blue dye particles were evident in histological sections of the layer. This would indicate that the layer is dyed PROLENE polymer and not an isolated protein coating on the strands.

Figure 4 - Sample 6 photographed against a white background showing the blue color of the cracked surface layer, 7 years, size 5-0, magnification x40.
